CEN22FA331

EXEMPLAR HELICOPTER AND IPAD EXAMINATION SUMMARY

Location: North Fork, Idaho
Date: July 21, 2022
Time: 1644 mountain daylight time (MDT)
2244 coordinated universal time (UTC)
Helicopter: N388RA, Columbia Helicopters CH-47D

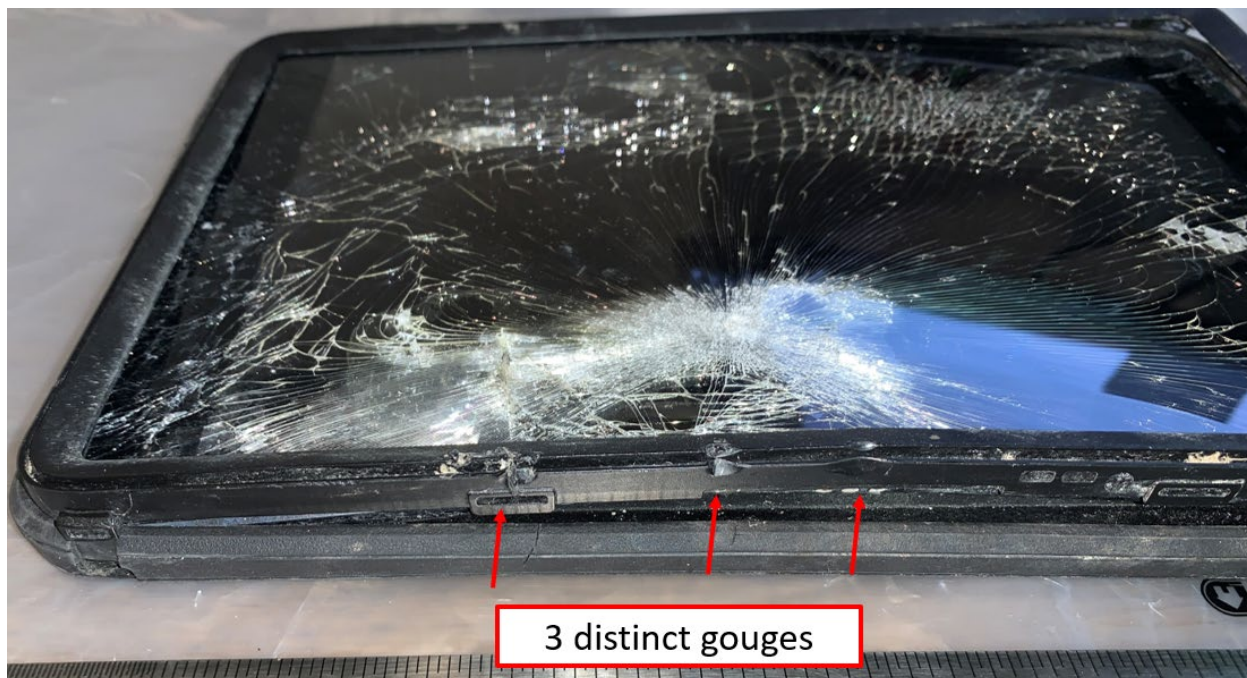
During recovery of the accident helicopter, the flight crew's Apple iPad was found in the river near the cockpit. Figure 1 shows the overall damage to the iPad as recovered. There were three distinct gouge marks on the left side of the iPad and its case, when viewed in portrait mode. The iPad exhibited abend from the back of the case toward the screen. The top two gouges extend from the edge of the case inward into the screen about 3 inches. The bottom gouge is shallower and does not extend into the screen.

Figure 1. Condition of iPad after the accident with 3 distinct gouges in the iPad and its case. The gouges are on the left side of the iPad when viewed in portrait mode. In the image, the iPad is rotated left into landscape mode.

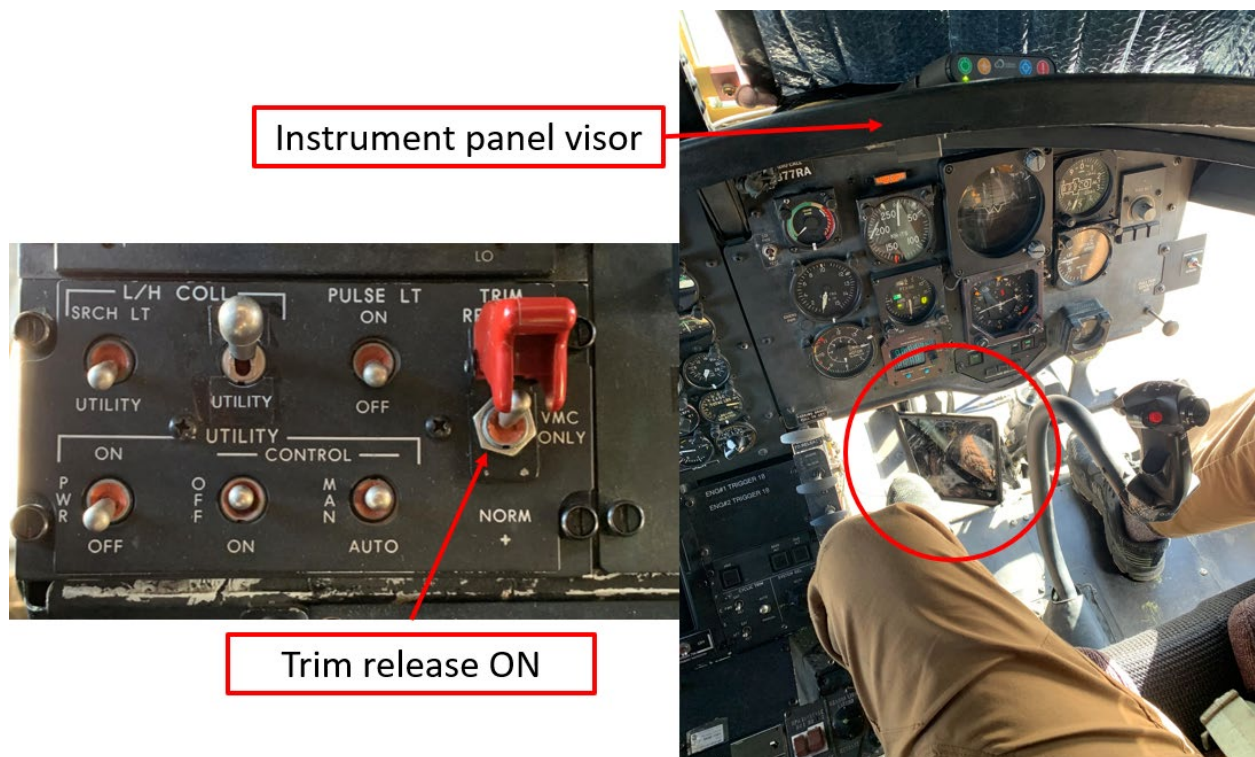
Figure 2. Trim release ON and iPad placed in co-pilot's left pedal area.

With the seat restraints on and seats adjusted for comfort, both a 5'7" male and 6'2" male could not reach the iPad in this position. The accident co-pilot's height was 5'10". Additionally, wearing a flight helmet would limit the ability to reach down as the flight helmet would contact the instrument panel visor as seen in Figure 2 and Figure 6.

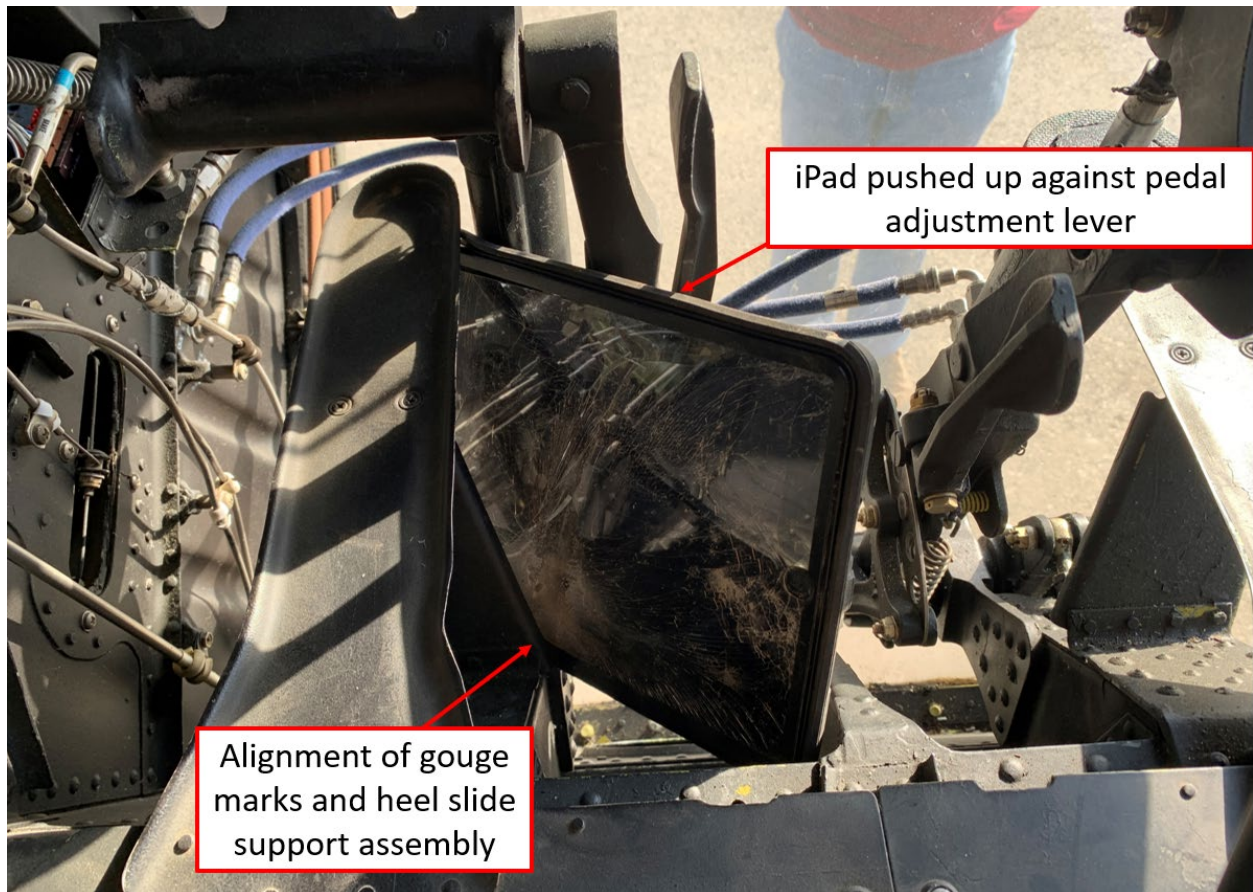
When pressure was applied to the pilot's right pedal, the iPad was squeezed in between the pedal and the heel slide support assembly, which was concentrated near the gouges. The gouges in the iPad aligned with a sharp, vertical metal piece of the heel slide support assembly underneath the heel slide, as seen in Figures 3, 4, and 5. Additional right pedal input forced the iPad to apply more pressure to the co-pilot's pedal adjustment lever.

Figure 3. The iPad impinged in between the co-pilot's left pedal and the airframe. The back side of the iPad is pushing against the left pedal adjustment lever. The lower left corner of the iPad is lodged into a small corner of the airframe. The gouges in the iPad aligned with a sharp, vertical metal piece of the heel slide support assembly.

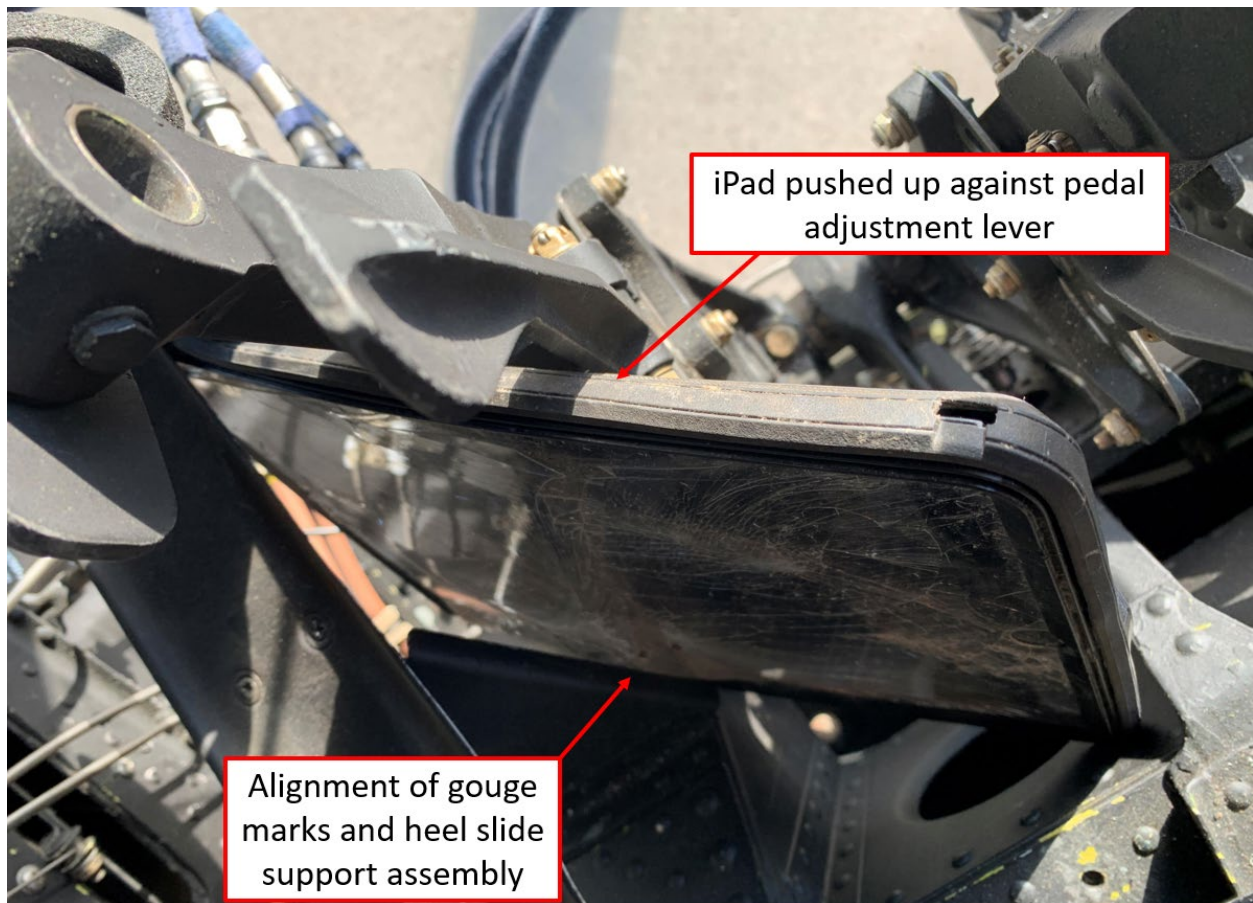
Figure 4. The iPad impinged in between the co-pilot's left pedal and the airframe. The back side of the iPad is pushing against the left pedal adjustment lever. The lower left corner of the iPad is lodged into a small corner of the airframe. The gouges in the iPad aligned with a sharp, vertical metal piece of the heel slide support assembly.

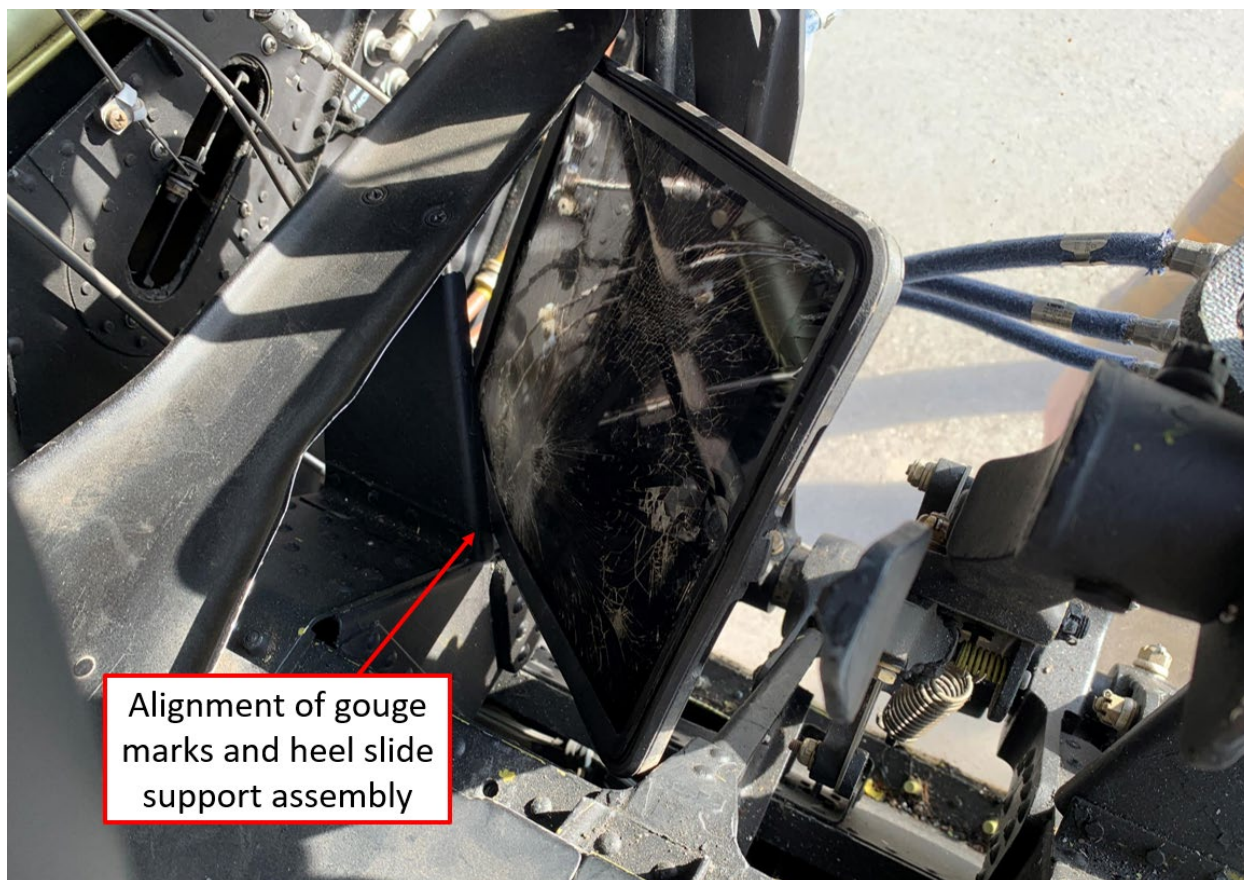
Figure 5. The iPad impinged in between the co-pilot's left pedal and the airframe. The lower left corner of the iPad is lodged into a small corner of the airframe. The gouges in the iPad aligned with a sharp, vertical metal piece of the heel slide support assembly.

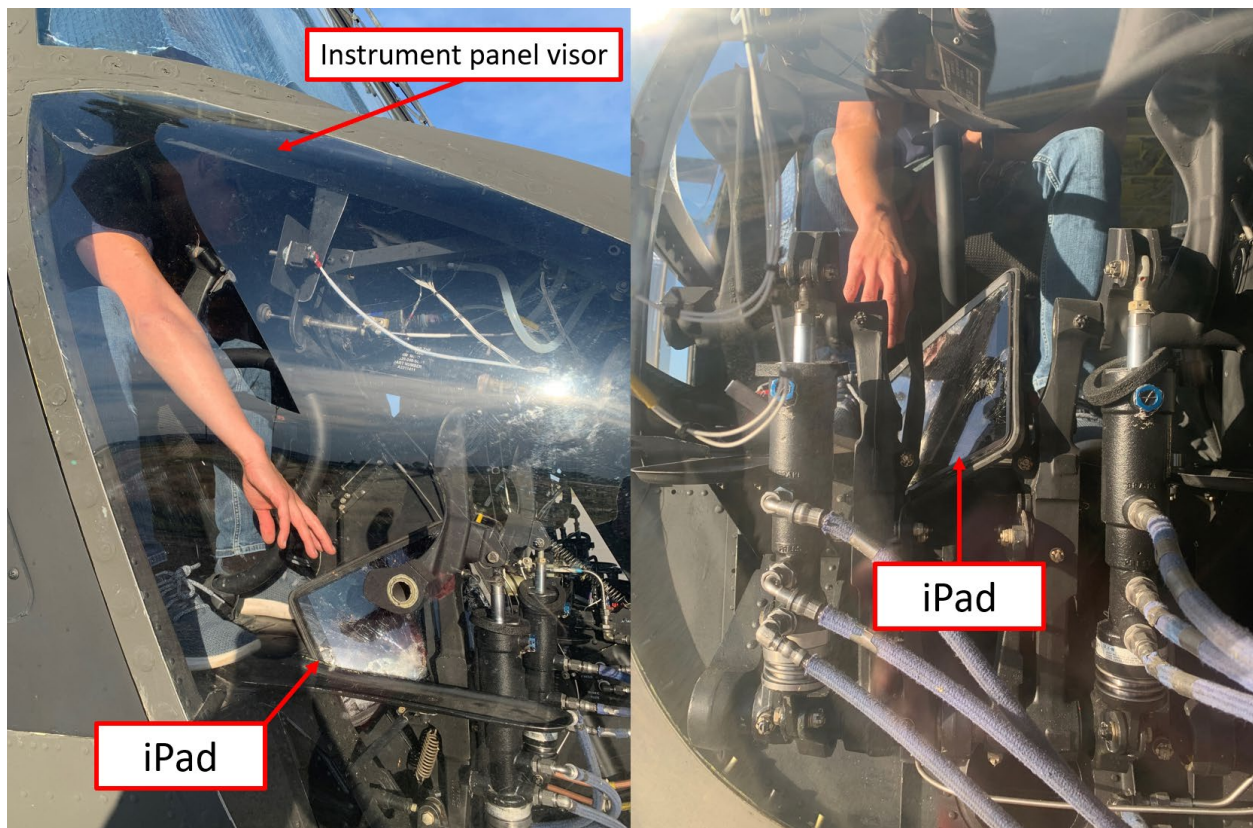
Figure 6. Exemplar 5'7" male wearing seat restraints is reaching for the iPad. The restraints and instrument panel visor prevent the iPad from being accessible.
